# Lessons from Feasibility and Conceptual Design Studies for a Potential Groundwater Underdrain Remedy

*Nelson Tunnel / Commodore Waste Rock Superfund Site  
Colorado*

Adam Piestrzeniewicz, PG  
DCHWS West 2025

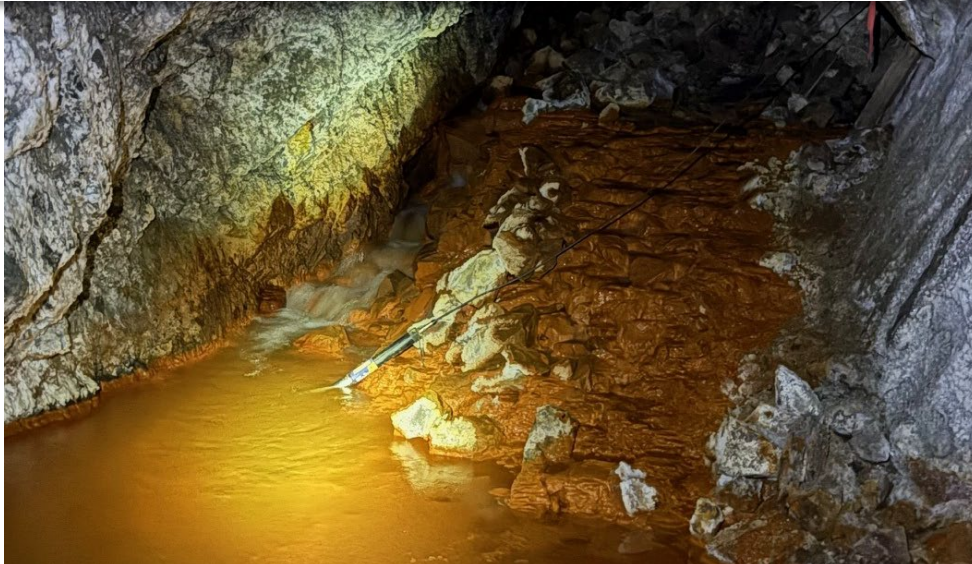
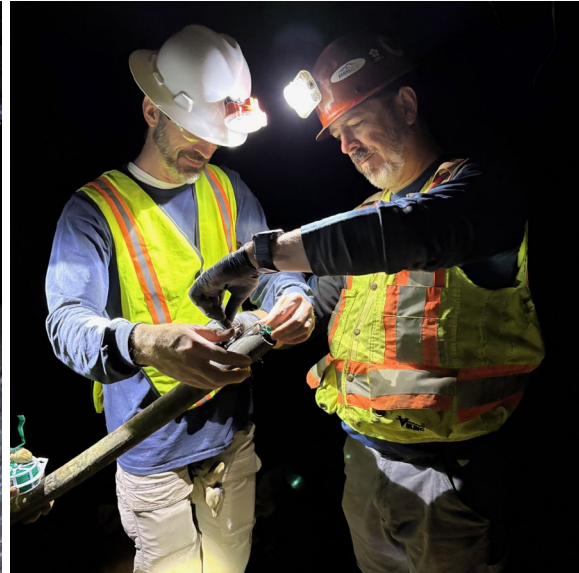
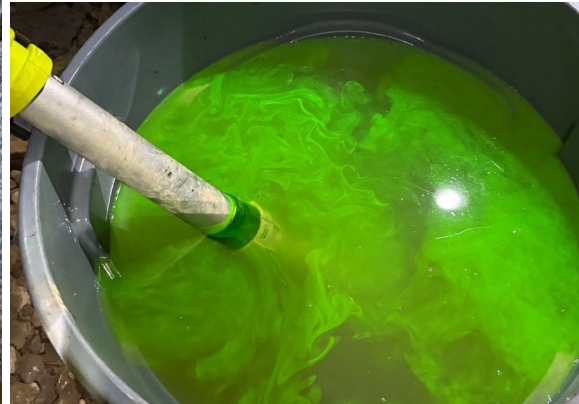
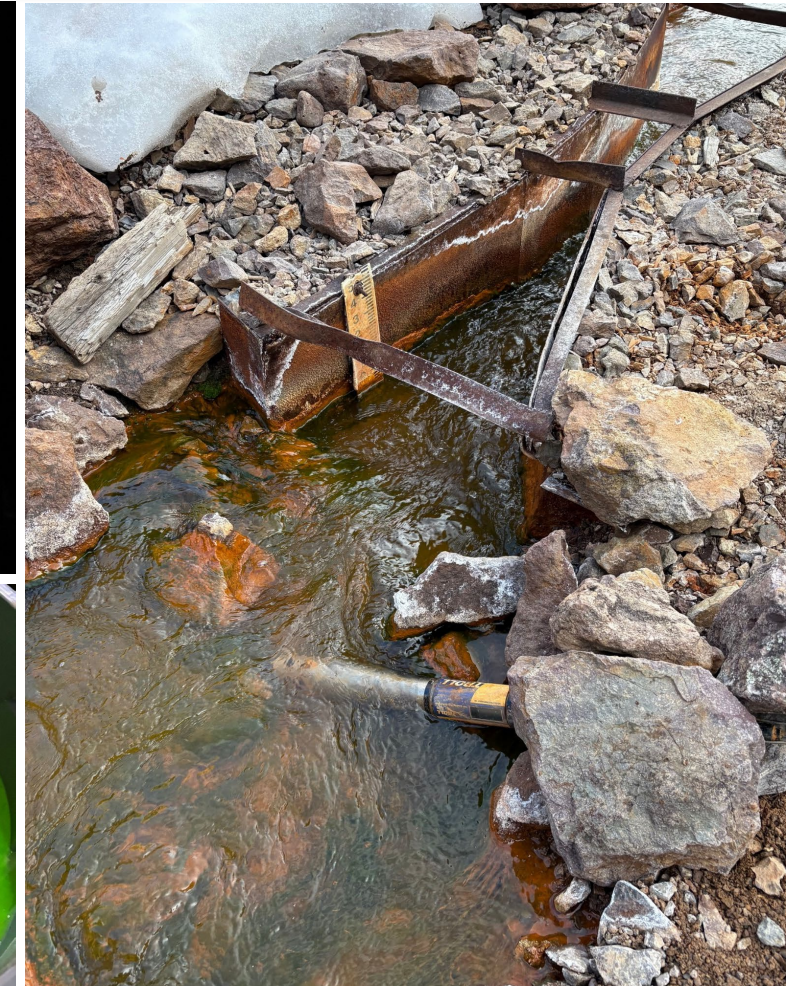
# Tracer Study

- Injection of fluorescein dye and lithium chloride tracers into WS-1
- Monitoring and sampling (sondes, charcoal samplers, and servosippers)
